NATIONAL ADVISORY COMMITTEE FOR AERONAUTICS

TECHNICAL NOTE

No. 959

AXIAL FATIGUE TESTS OF 10 AIRPLANE WING-BEAM SPECIMENS
BY THE RESONANCE METHOD

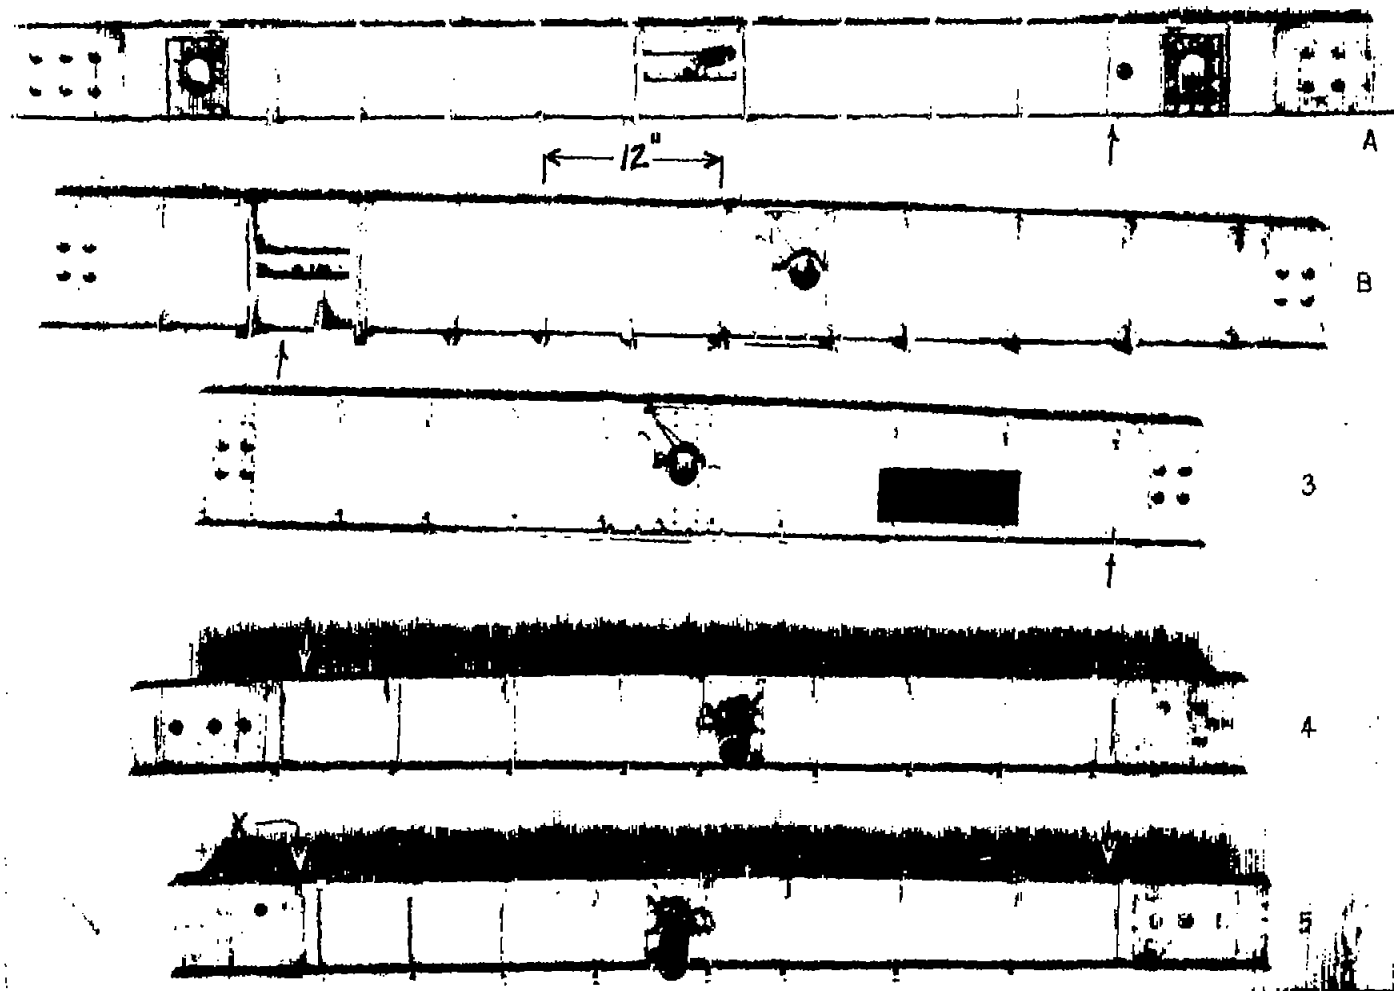
Figure 1.- Specimens A, B, 3, 4, and 5 after failure. The extent to which the specimens were imbedded in the terminal fixture is shown by the discolored area at the ends. Arrows indicate the principal failure.

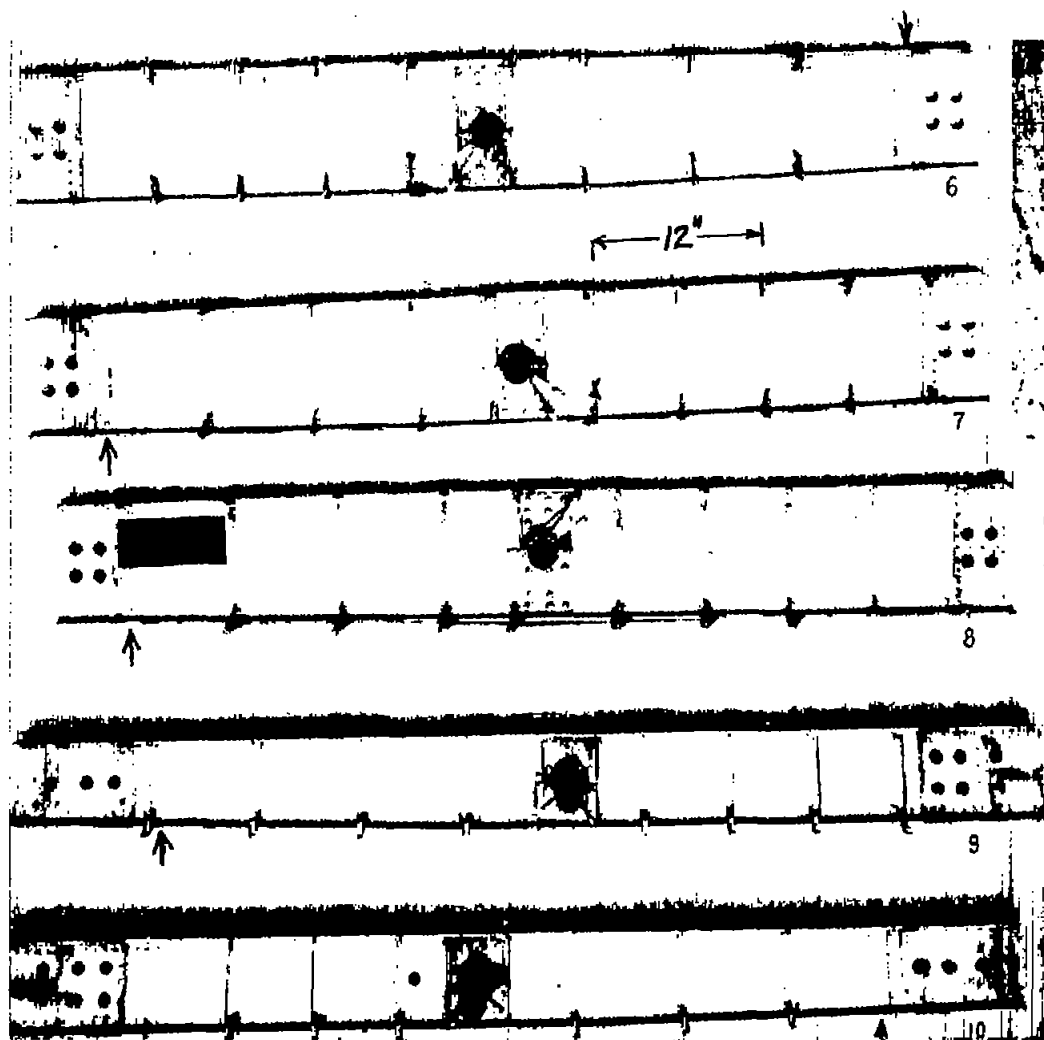
Figure 2.- Specimens 6 to 10 after failure.

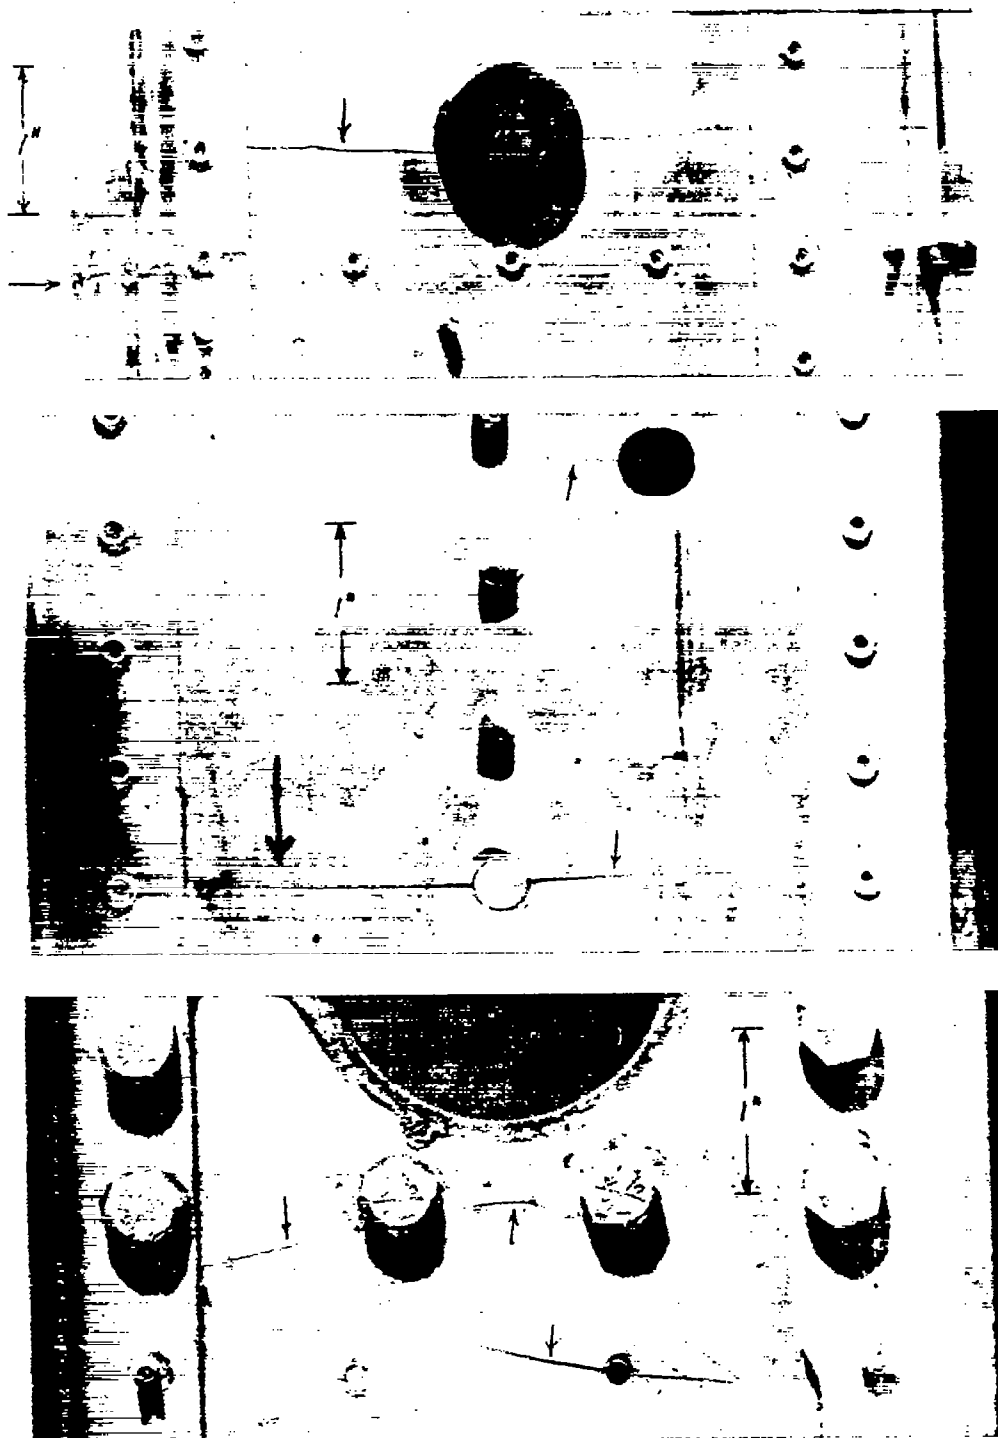
Specimen A, figure 11: Fracture passed through a 13/16-inch unfilled hole on the center line of web, and three filled rivet holes in the flange. Six other web cracks were found in the flange and are shown in reference 2, figures 22 and 23.

Specimen A, which was unspliced, failed at a 13/16-inch unfilled hole in the web; k_f was only slightly higher than the theoretical value of about 3, although still appreciably higher than the factor obtained on type-II specimens. It is believed that there is a possibility of size effect here. Such an effect has been observed in another investigation of the fatigue strength of strips containing holes, but these tests are as yet too incomplete to estimate this effect for specimen A.

Figure 11.- Fatigue cracks and fracture of specimen A. The principal failure which passes through three rivet holes in the flange and a $\frac{13}{16}$ -inch grommated hole in the web is shown at the top. The two holes in the flange were occupied by rivets fastening a portion of a rib; this was removed after failure to expose the fracture.

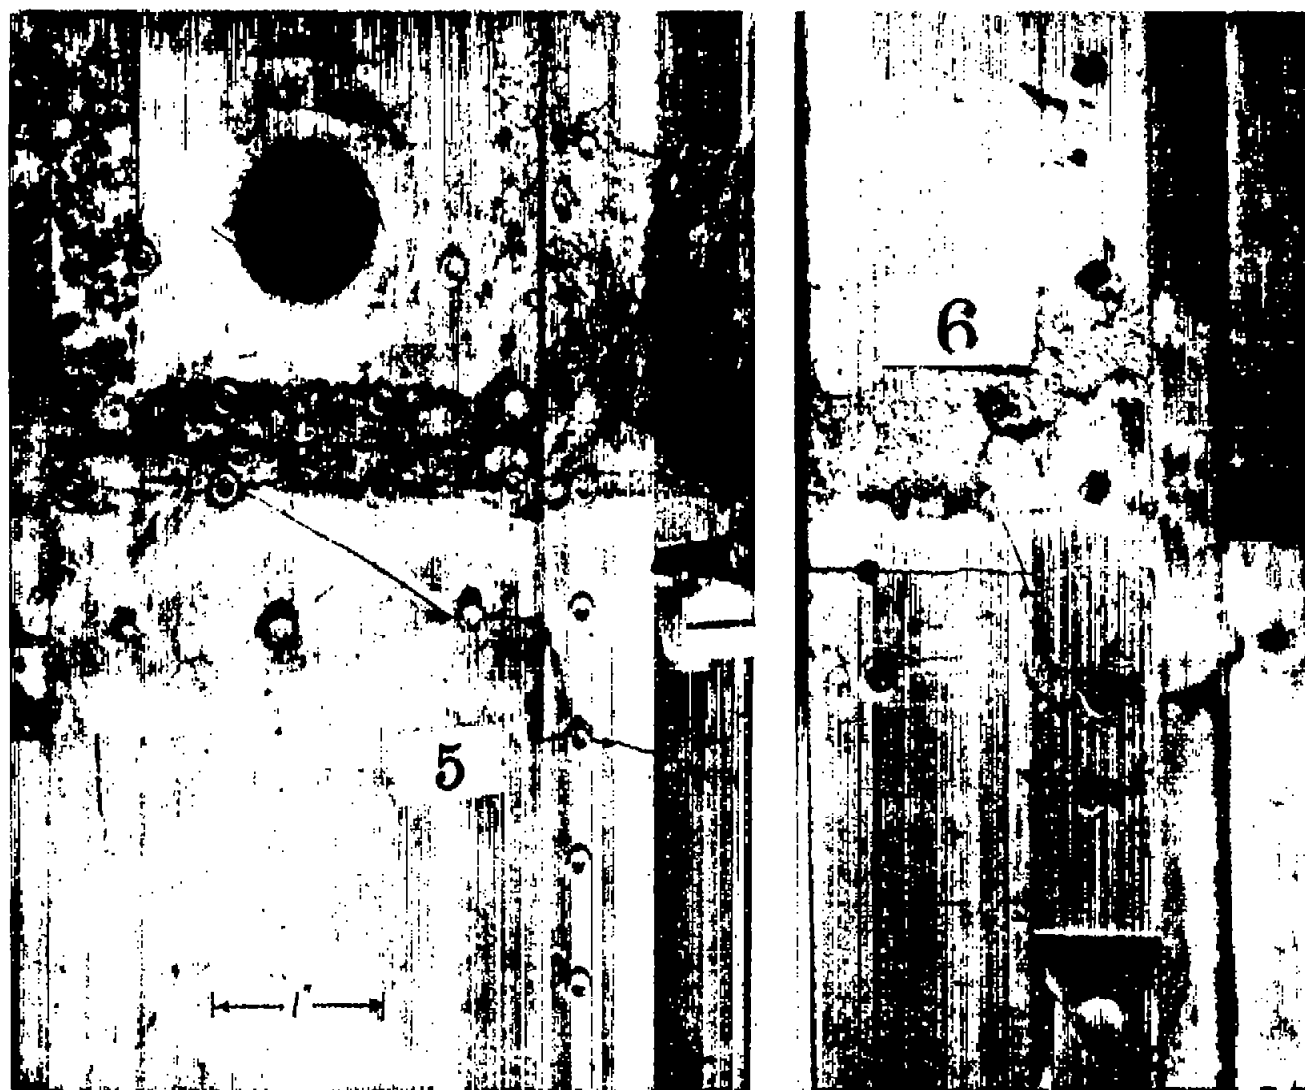
Figure 14.- Fractures of specimens 5 and 6.

Specimen 5, figure 14: Failed through web splice and stem rivet of flange. Crack is believed to have started in web at about 2,000,000 cycles.

Specimen 6, figure 14: Flange failed opposite web splice. A crack was first noticed at about 10,000,000 cycles at a rivet hole in the outside of the flange and spread inward toward the stem.

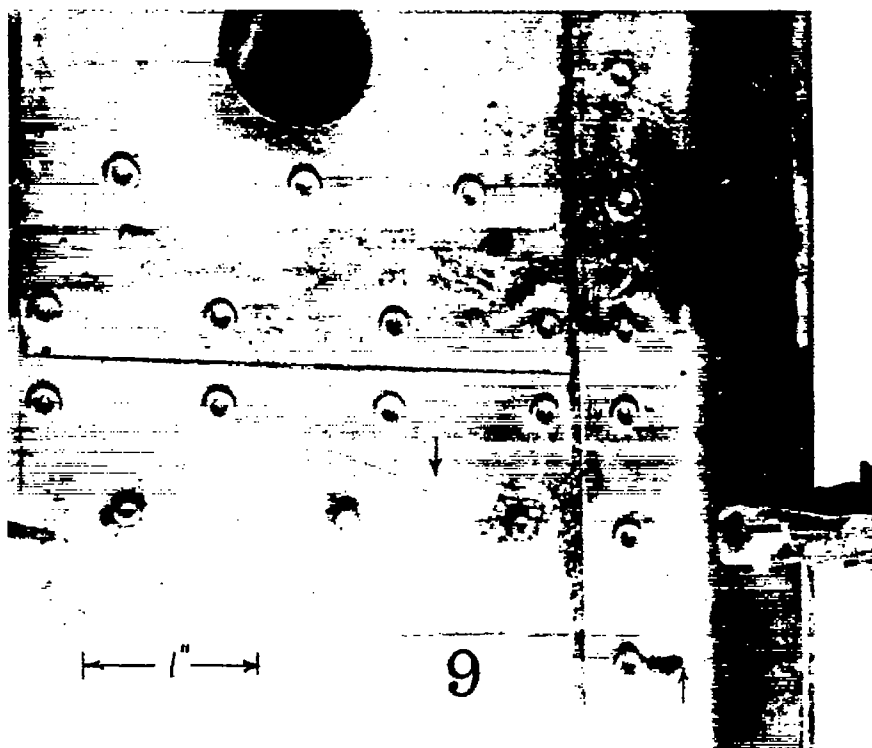
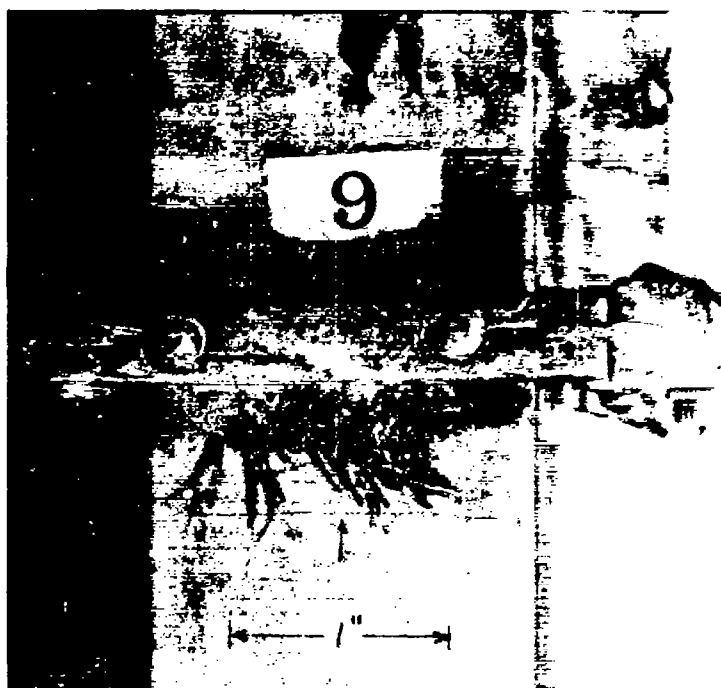
Specimen 9, figure 16: Failed at web splice in the same manner as specimen 5.

Figure 16.-
Two views
of the
fracture
of speci-
men 9.
